a guide for the
geologic and hydrologic evaluation
of small lake sites in missouri

Dean, Thomas J., James H. Barks and James H. Williams, 1976, A GUIDE FOR THE GEOLOGIC AND HYDROLOGIC EVALUATION OF SMALL LAKE SITES IN MISSOURI: Mo. Dept. of Natural Resources, Geological Survey, WR 31, 56 p., 24 figs., 2 app.

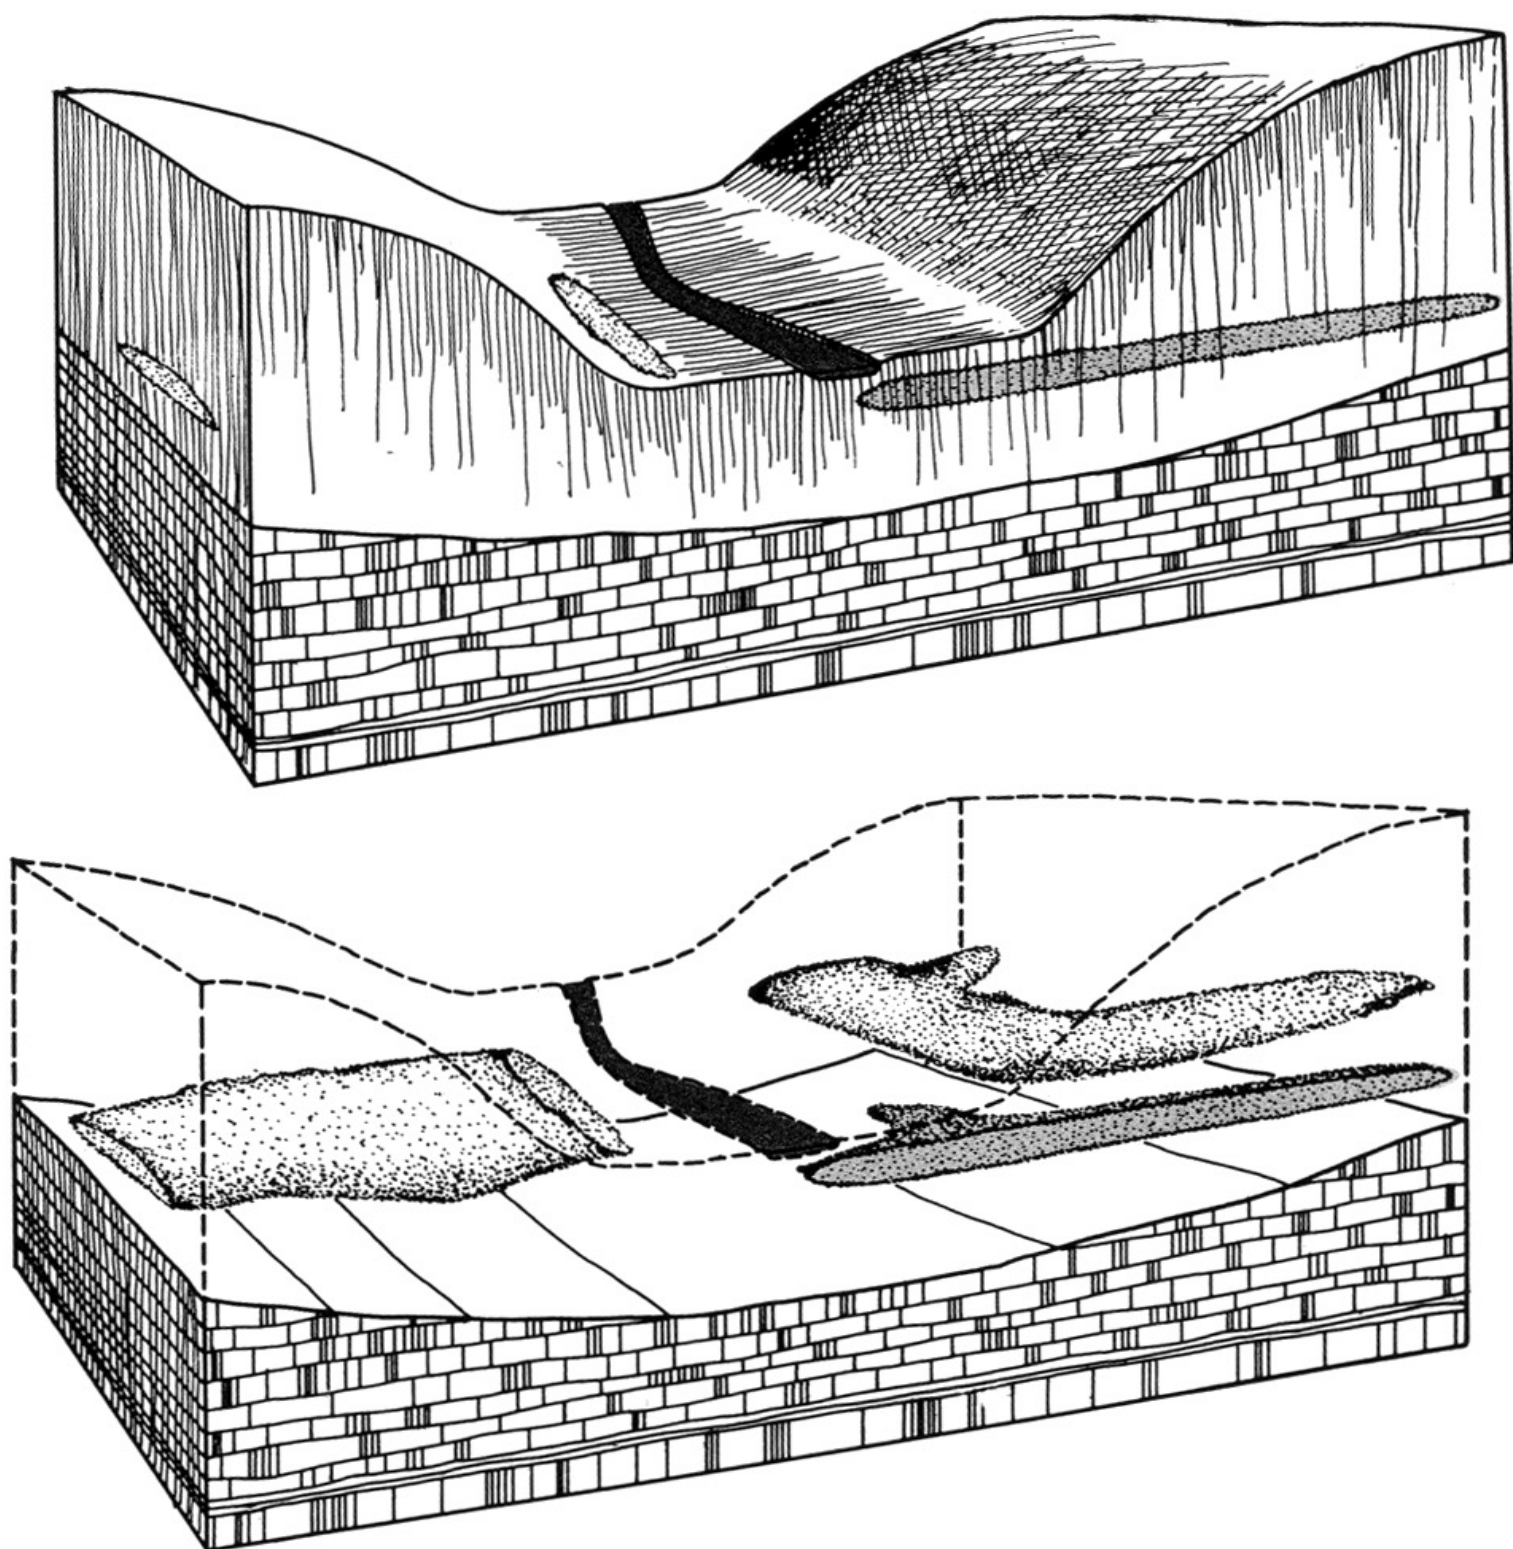
Figure 18

Schematic diagram of a valley cross section with sand pockets in glacial till and deep alluvium.

Glacial soils (Area 1) have pockets or lenses of sand and gravel, as shown in figure 18, which cannot always be predicted from surface evidence. These coarse textured materials create serious leakage problems where they are located in the valley slopes or lake bottoms.

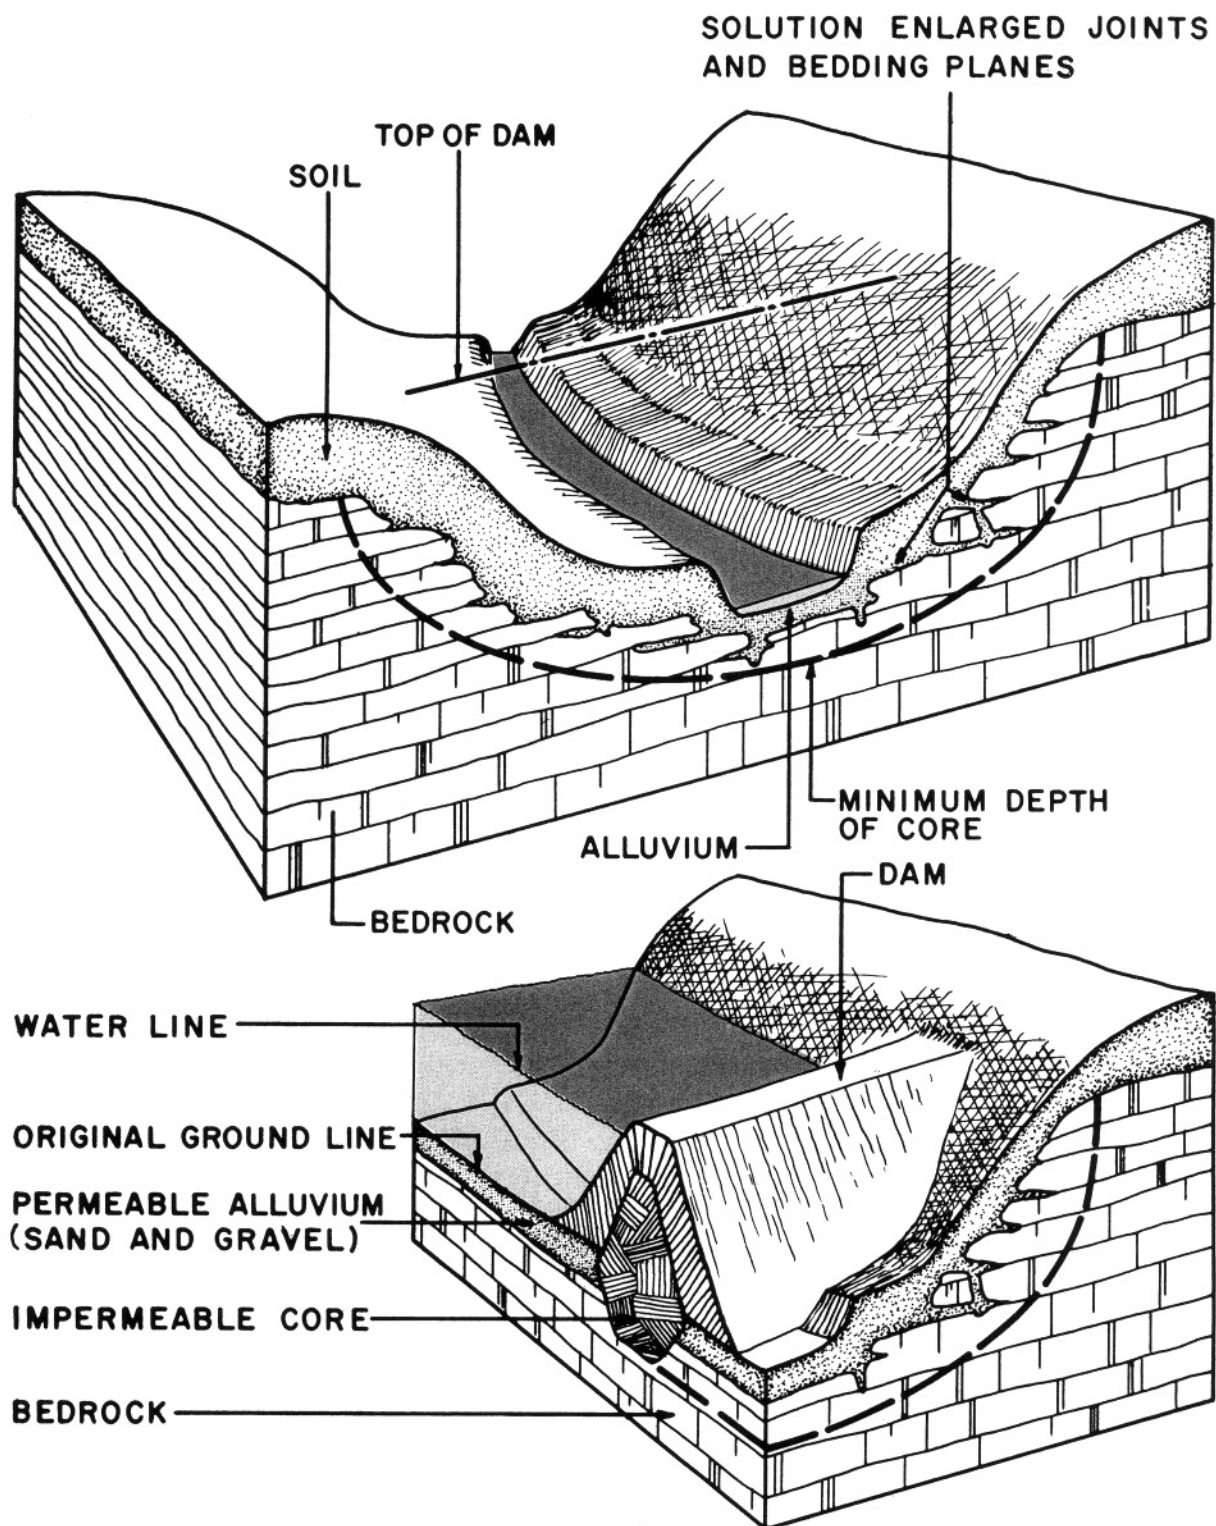
Figure 19
Schematic diagram of the core of a dam.

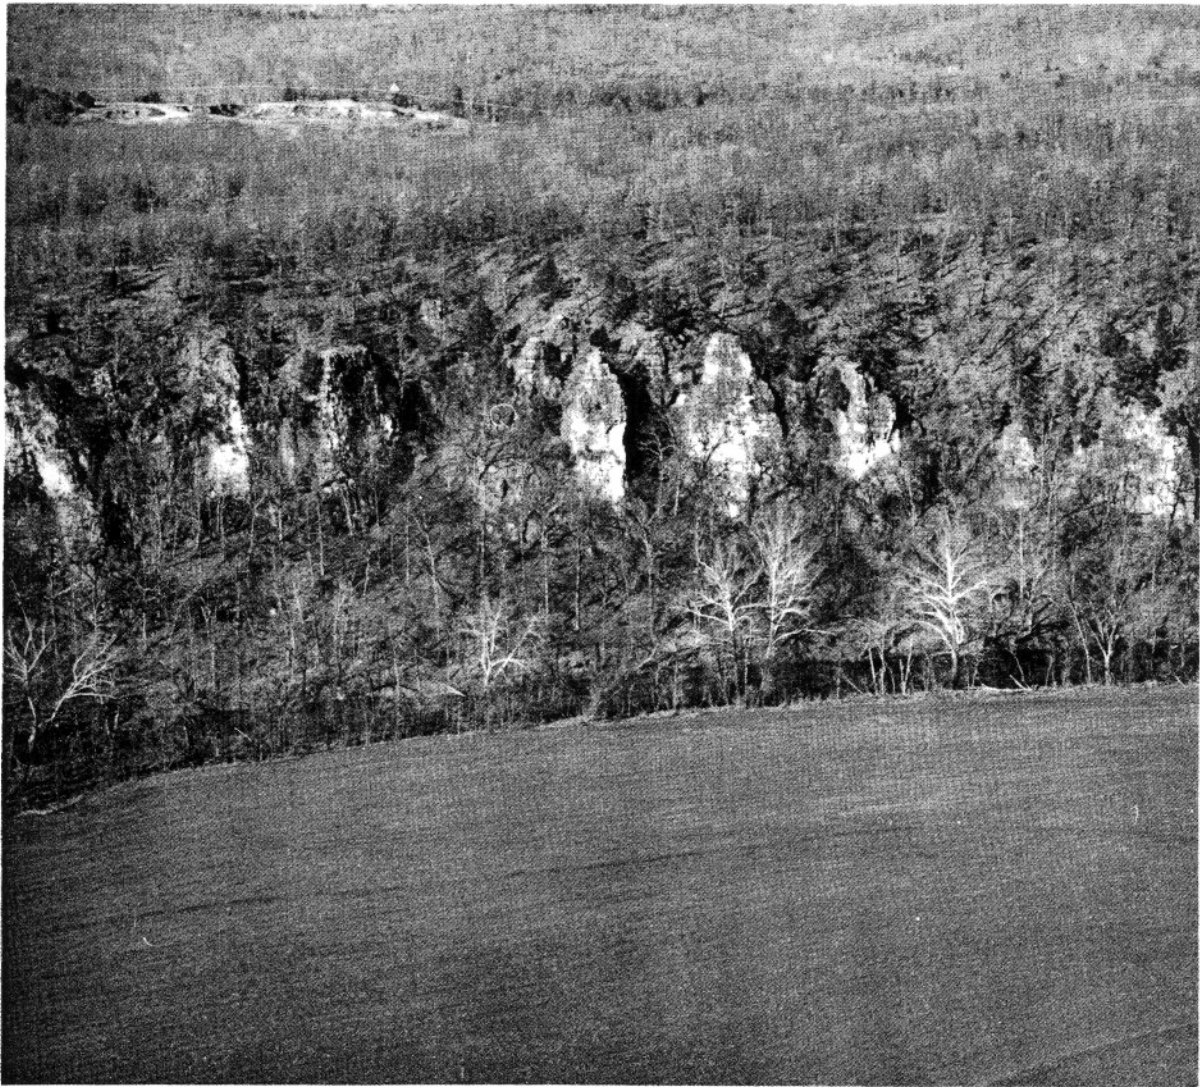
Figure 20

Extensively weathered areas resulting in extremely permeable bedrock (where caves and sinkholes are likely) are not good water impoundment settings. Photo by David Rath.

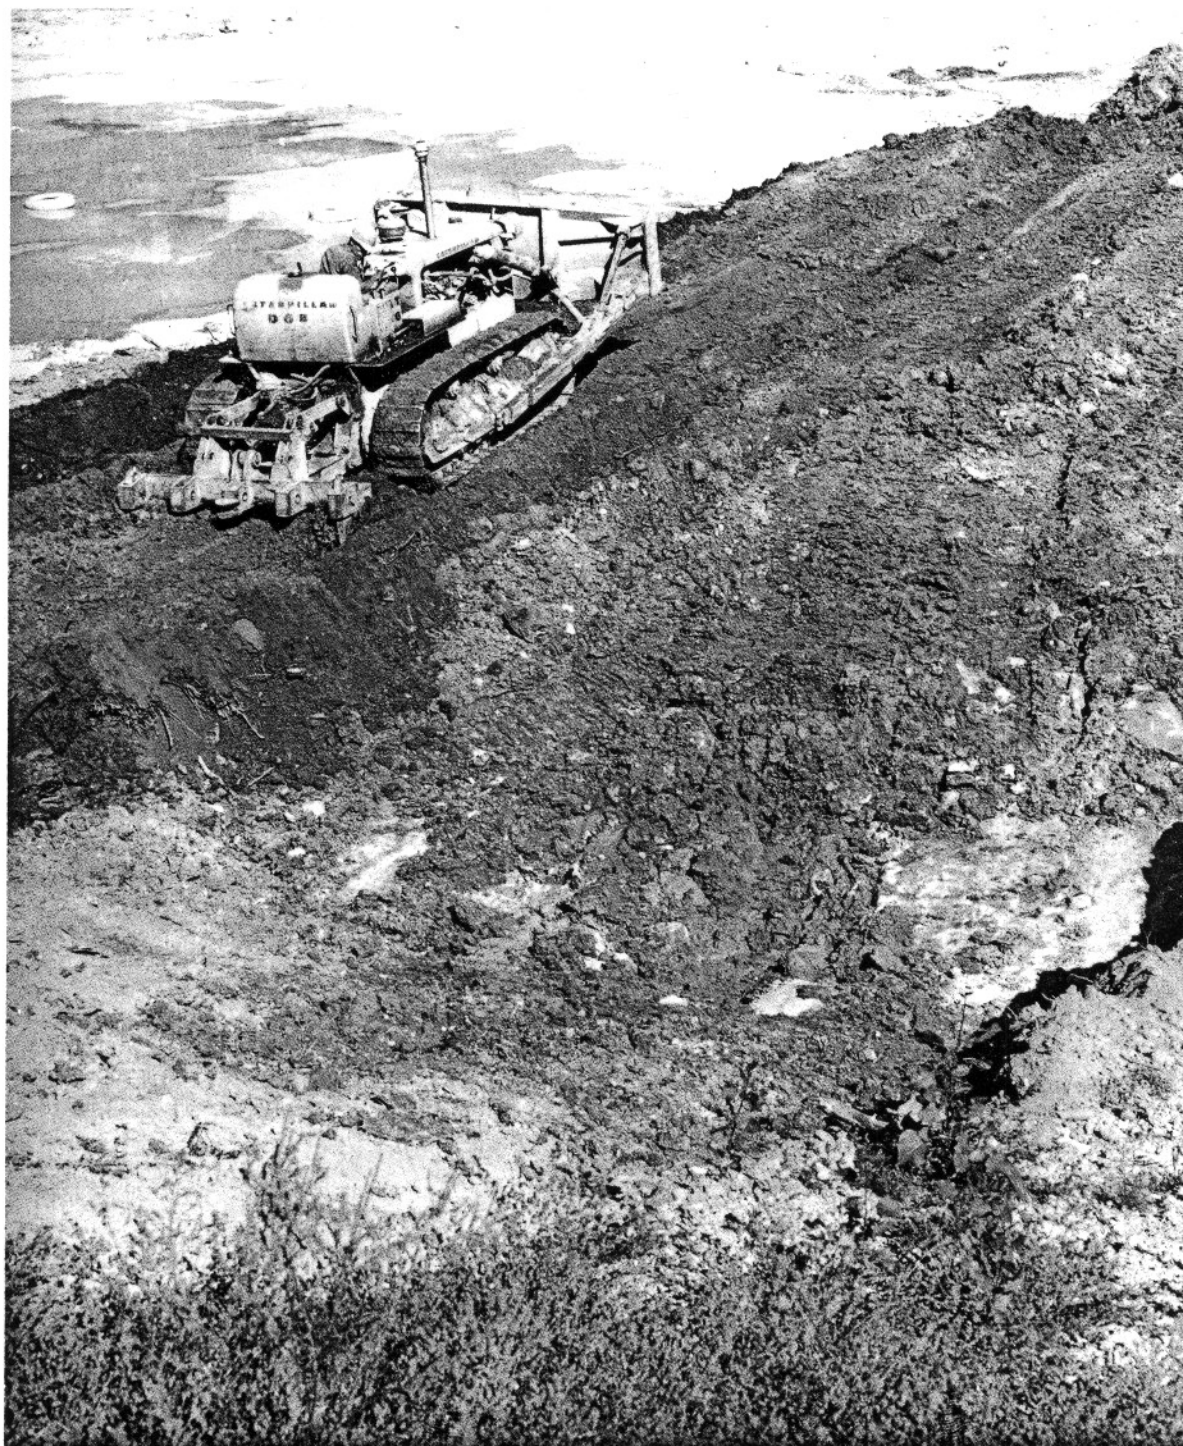
Figure 21

A leaky lake can sometimes be repaired by sealing the permeable limestone rock in the lake bottom. Photo by Jerry D. Vineyard.

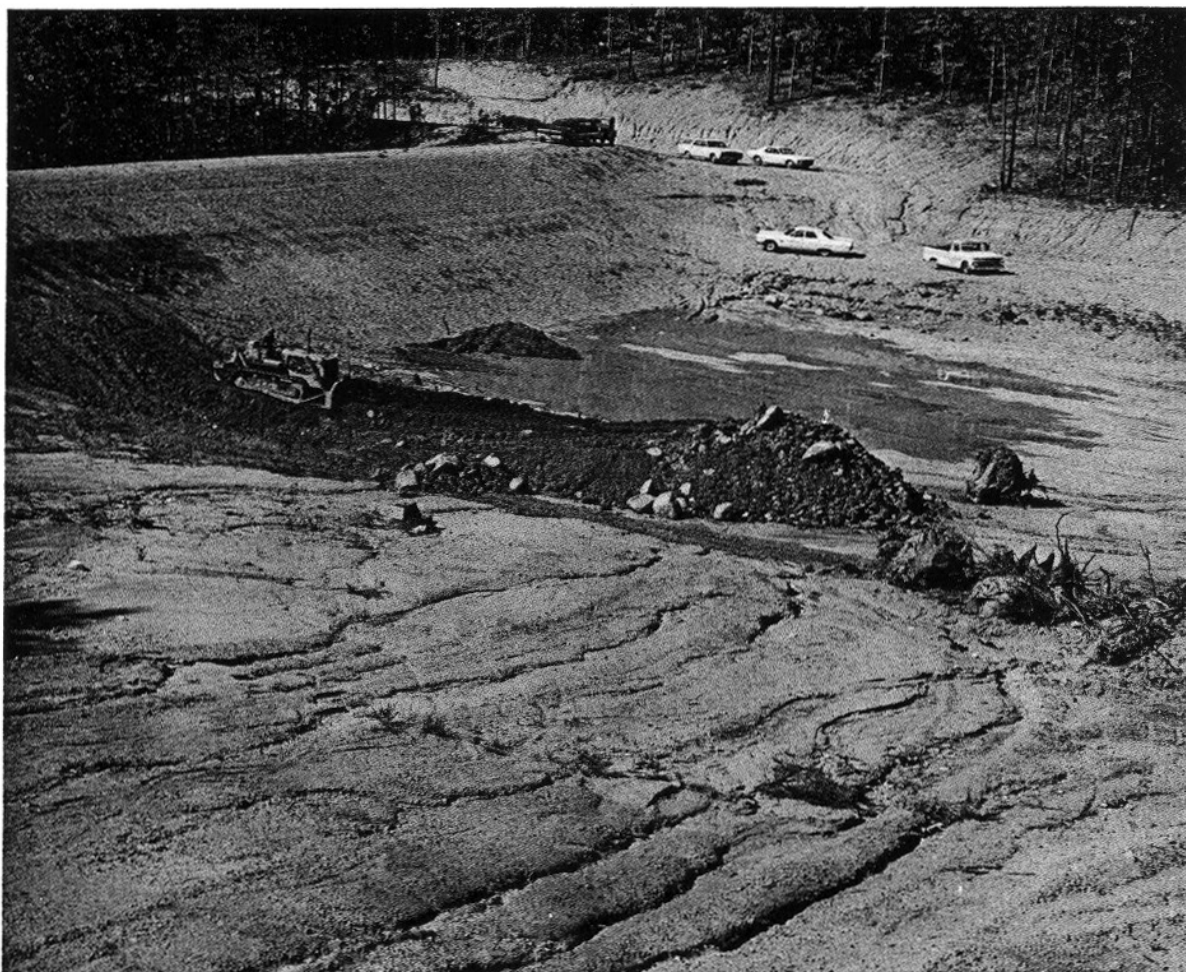
Figure 22

To prevent leakage under a dam, a clay pad can be put in the lake bottom. Photo by Jerry D. Vineyard.

venting water from entering the bedrock. Padding is used mainly in very small lakes where the entire basin below the waterline can be covered (fig. 22).

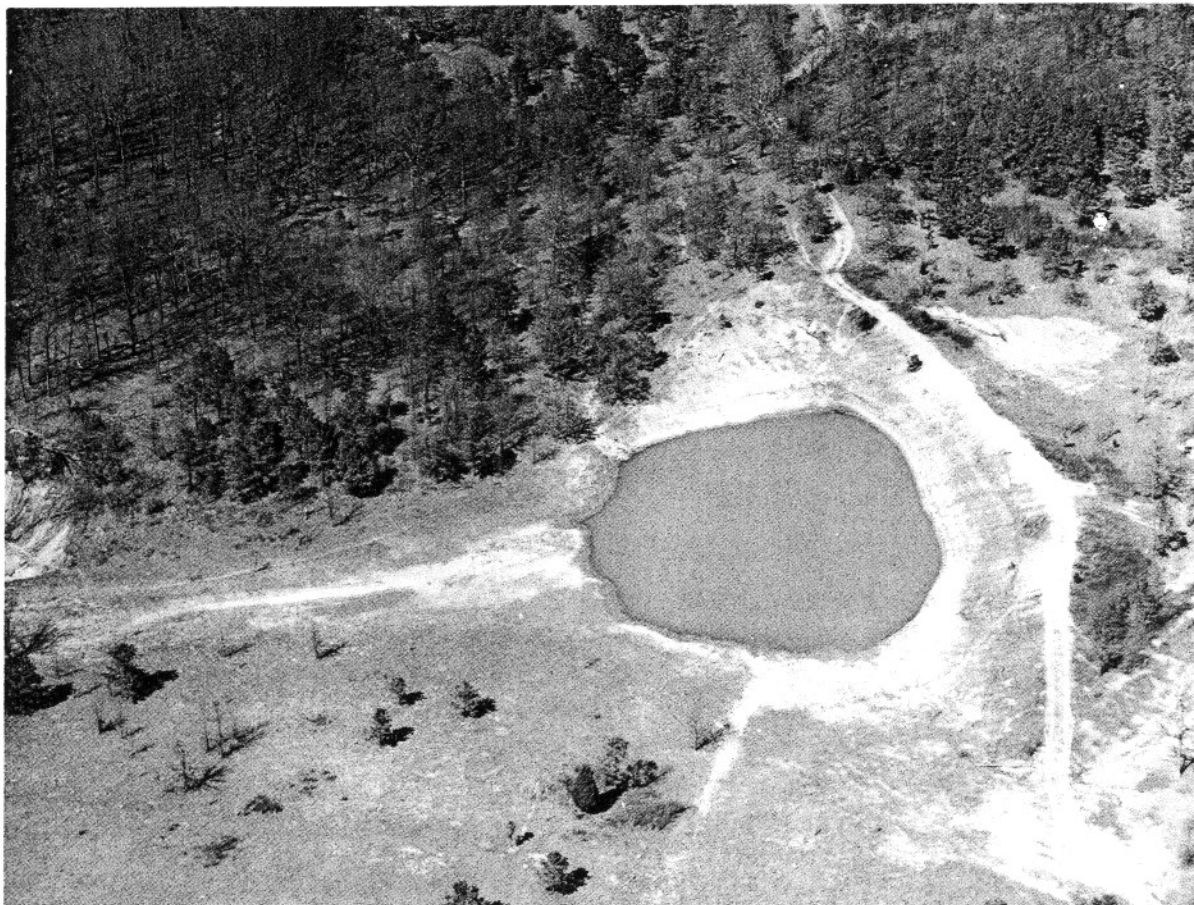
Figure 23

The potential for collapse of the bottom of this lake could probably have been predicted by a preconstruction investigation. Photo by Jerry D. Vineyard.

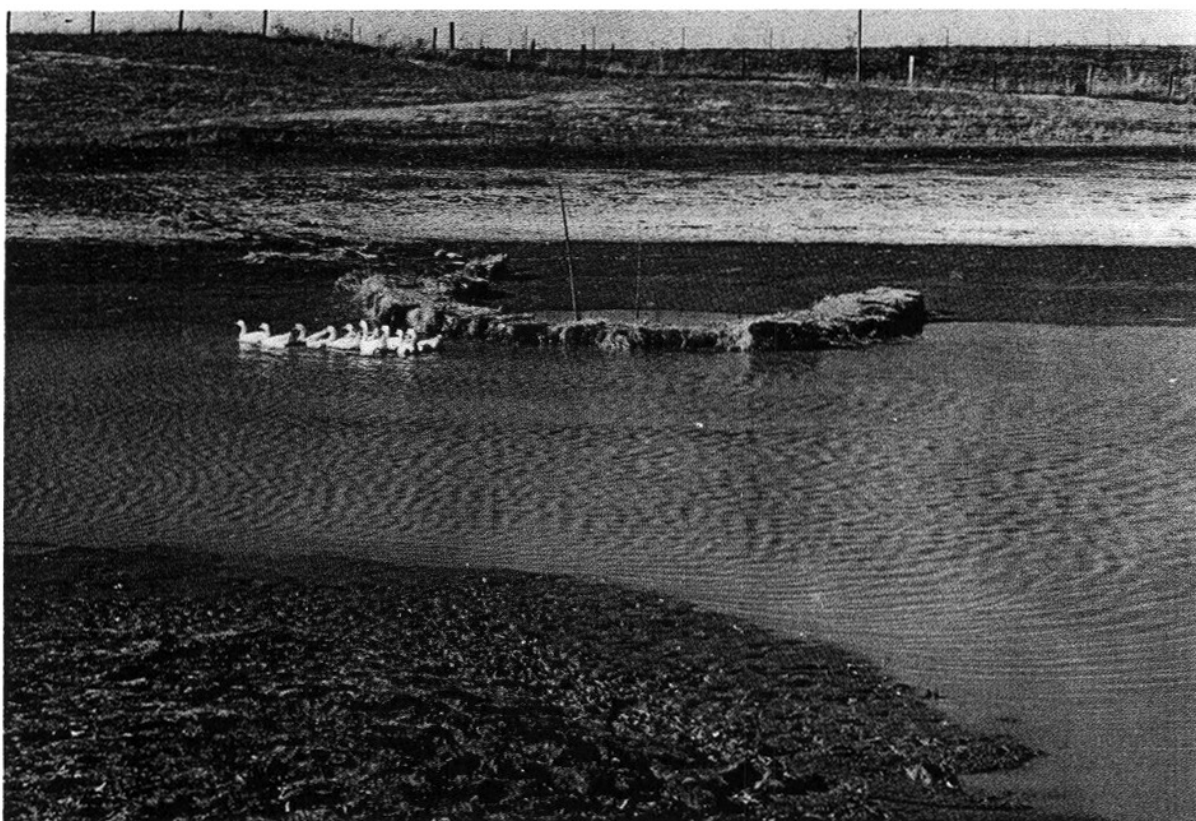
Figure 24

Siltation of a lake can quickly destroy its usefulness. Photo by Jerry D. Vineyard.
